NAS CR-120865
WANL-M-FR-72-012
DECEMBER 1972

METALLURGICAL EVALUATION OF FACTORS INFLUENCING THE DUCTILITY OF AGED T-111

WESTINGHOUSE ASTRONUCLEAR LABORATORY

CONTRACT NAS 3-15560

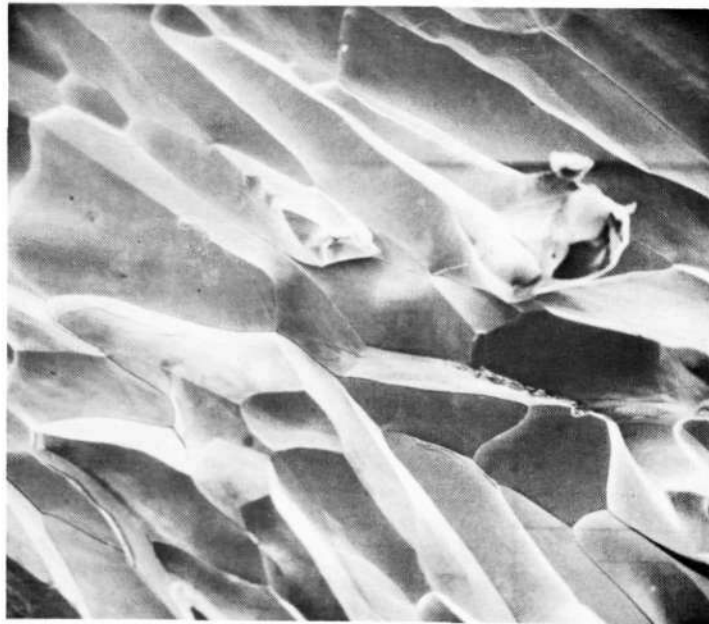
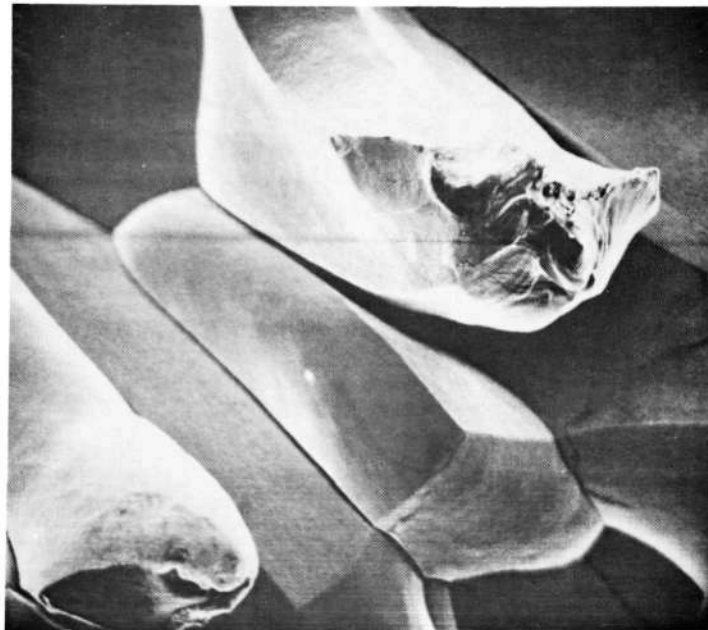
FIGURE 6. Microstructure of GTA Weld Specimen 1.

Specimen 1. This specimen was aged 1000 hours at 982°C (1800°F) in ultra-high vacuum. The microstructure after aging is shown in Figure 6. Precipitates have developed along the interdendritic boundaries of the weld fusion zone but there is no evidence of grain boundary precipitation. SEM examination of the bend-fractured specimen revealed failure had occurred due to separation along fusion zone grain boundaries, Figure 7. In the 450X micrograph (Figure 7) several of the elongated weld grains are seen to be tipped by regions of ductile rupture. Examination of the specimen fractured in the Auger apparatus indicated failure had occurred largely in the same manner, but isolated regions of cleavage and dimpled rupture were present.

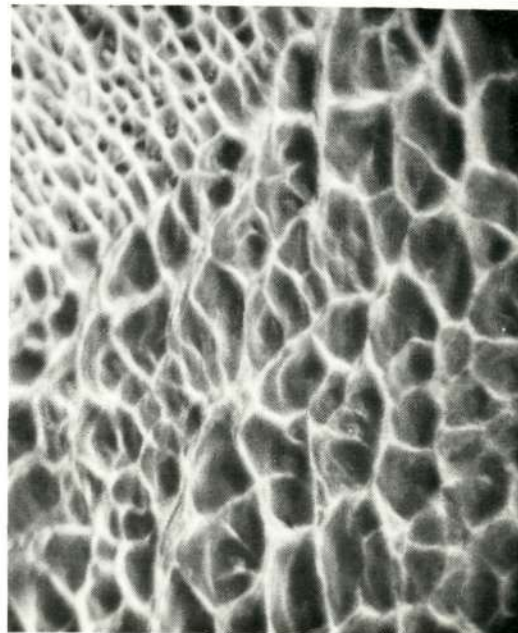
FIGURE 9. Scanning Electron Micrographs of Fracture Surface of GTA Weld Specimen 2 ; Fractured at -196°C (-320°F).

Specimen 2. This specimen is identical to specimen 1 (1000 hours-982°C(1800°F)) except for the use of a 1 hour-1982°C(3600°F) post-age anneal. This anneal has resulted in extensive grain growth in the base metal and HAZ, Figure 8. The fusion zone has undergone less significant change. SEM examination of the fracture surface revealed a mixed fracture mode. Regions of the specimen displayed what appeared to be cleavage-type markings while others, apparently differing mainly in orientation, failed by a ductile, dimpled rupture. Micrographs of these various features are shown in Figure 9.

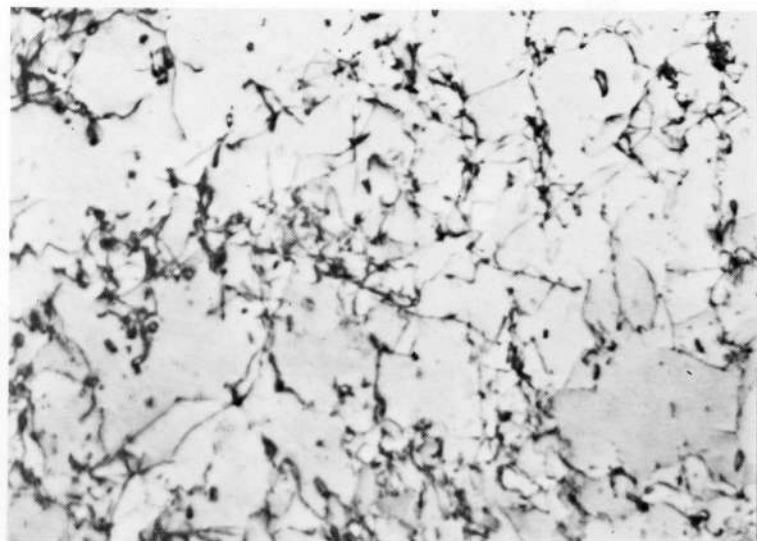
FIGURE 10. Transmission Electron Micrograph of Weld Zone Structure in GTA Weld Specimen 2.

Transmission electron microscopy revealed very little difference between this specimen and specimen 1. Figure 10 is a micrograph of a foil prepared from the weld fusion zone. Some dislocation tangles are in evidence but very little precipitation. Where precipitates were observed they were quite large and blocky and situated at the grain boundaries. Previous extraction and identification of this type of precipitate has shown it to be HfO_2 .

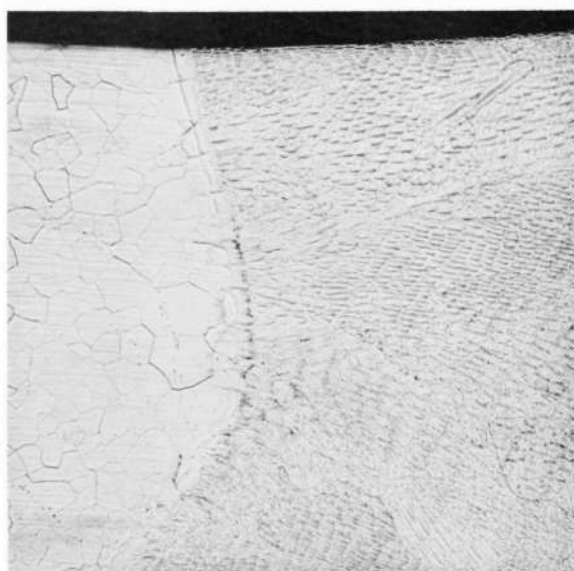
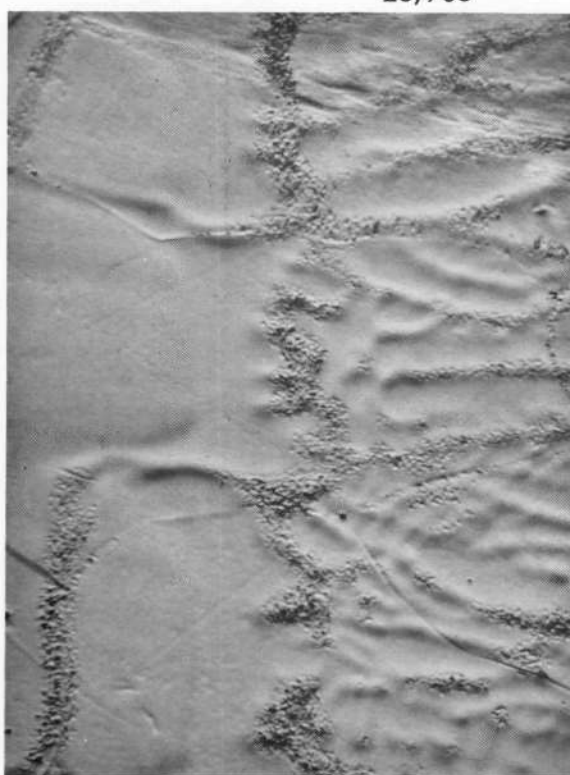
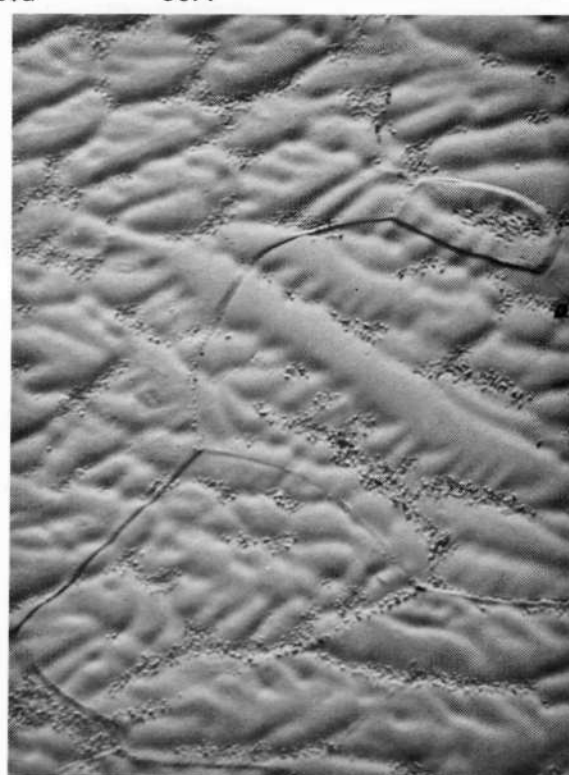
FIGURE 11. Microstructure of GTA Weld Specimen 3.

Specimen 3. Aged 5000 hours at 1149°C(2100°F) this specimen shows a microstructure much like that of specimen 1. Precipitation is interdendritic within the weld zone and nil elsewhere, Figure 11. SEM revealed the fracture morphology to be intergranular, the grain boundaries being quite clean and free of precipitation, Figure 12. The specimen fractured for Auger analysis at -150°C(-238°F) also failed by intergranular fracture but, although most grain surfaces were clean, some evidence of coarse precipitation was observed, Figure 13. Analysis of several of the larger precipitates with the energy-dispersive x-ray spectrometer of the scanning microscope showed very high hafnium content. These particles are probably

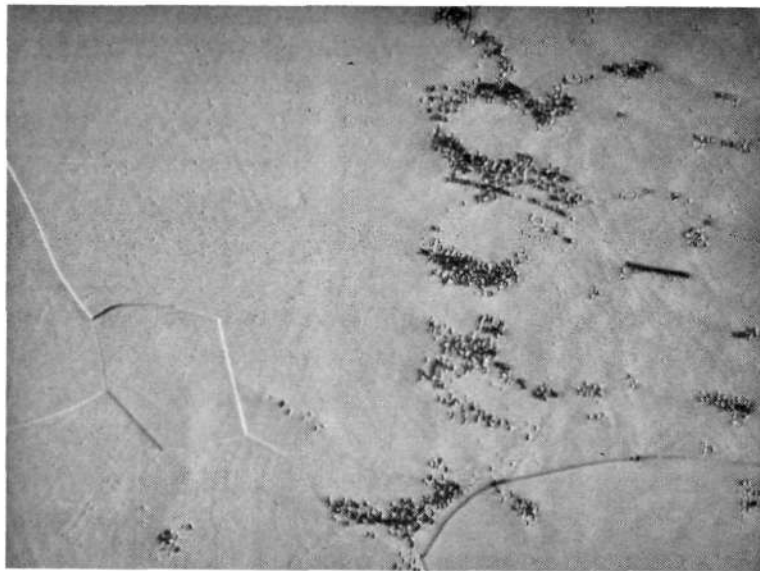
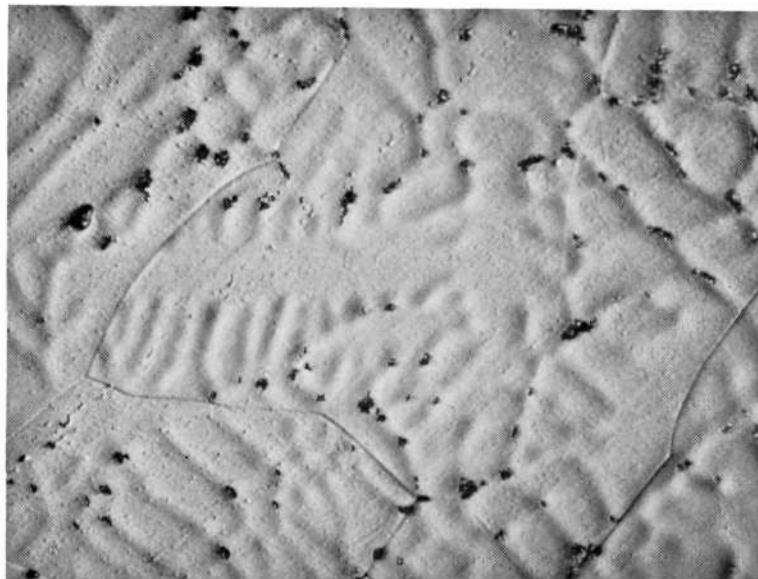
Specimen 4. The microstructure of this specimen, aged 10,000 hours at 1149°C(2100°F), is shown in Figure 14. The additional 5000 hour aging has not altered this appreciably from that of specimen 3 (Figure 11). Totally unexpected therefore was the ductile behavior of this specimen in bending at -196°C(-320°F). To completely fracture this specimen it had to be bent back and forth a number of times. Scanning micrographs of the fracture are shown in Figure 15. Regions of dimpled rupture quite often showed precipitate-void relationships such as seen in the 4500X micrograph of Figure 15.

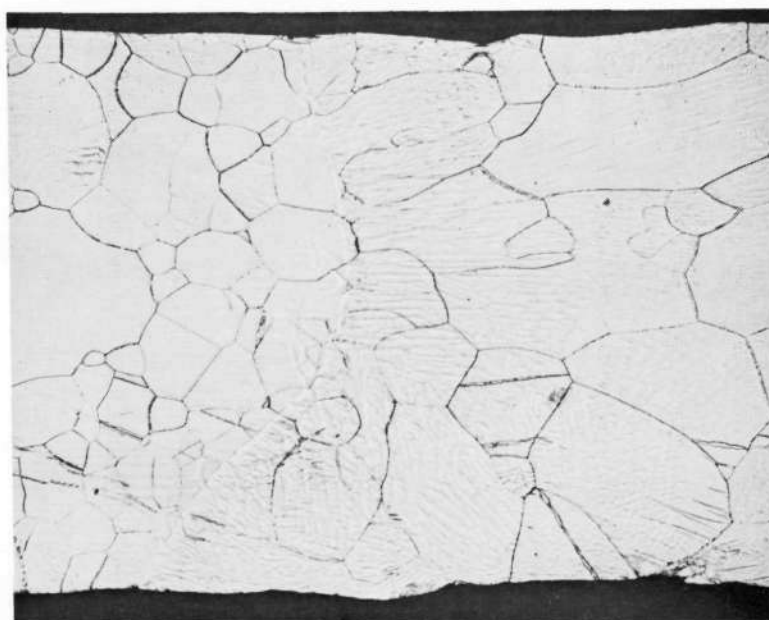
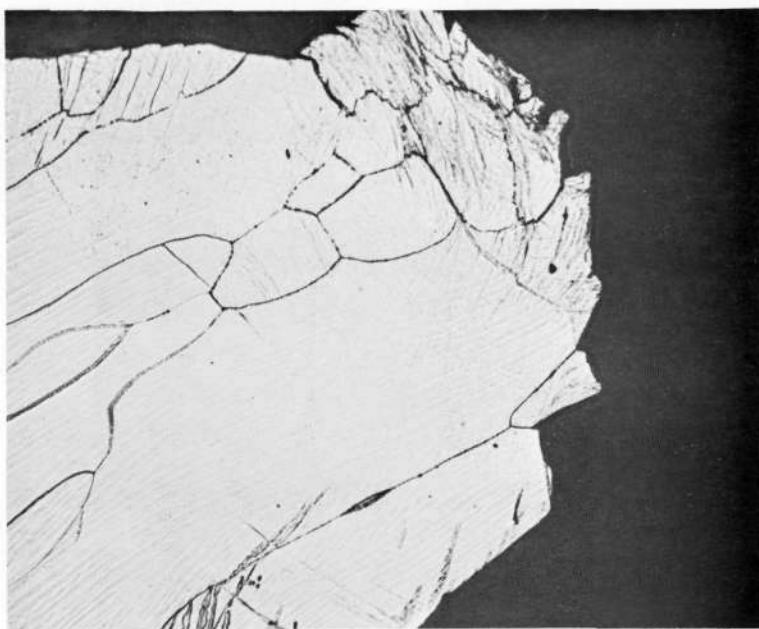
FIGURE 16. Microstructure of GTA Weld Specimen 5.

Specimen 5. This specimen was aged 10,000 hours at 1149°C(2100°F) and given a 1 hour-1982°C(3600°F) post-age anneal. The microstructure of the specimen bend-fractured at -196°C(-320°F), Figure 16, showed some evidence of deformation twinning in the fusion

zone. The fracture appears to have occurred by more than one process. SEM examination confirmed the mixed fracture mode, Figure 17. Fracture has been the result of cleavage and ductile rupture. Most of the regions of ductile rupture were characterized by a high concentration of precipitates within the dimpled pockets. Note the similarity between this specimen and specimen 2 (Figure 9) which was also given a $1982^{\circ}\text{C}(3600^{\circ}\text{F})$ post-age anneal.

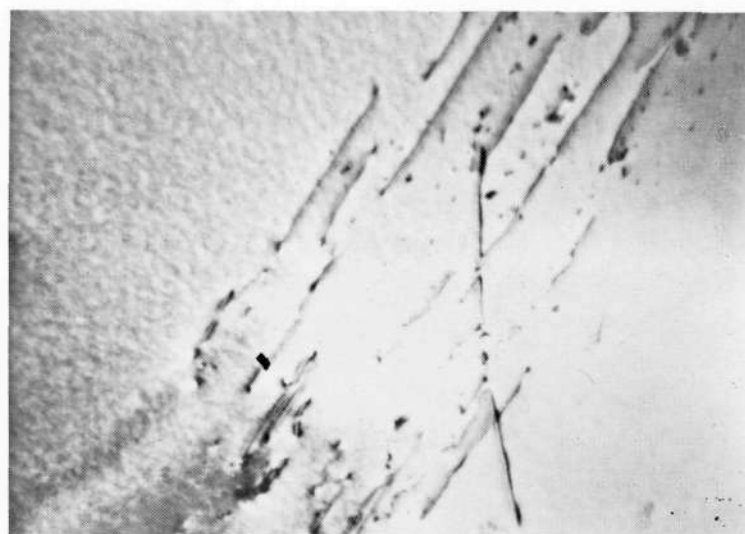
FIGURE 18. Transmission Electron Micrograph of GTA Weld Specimen 5.

TEM examination showed the fusion zone grain volumes to be relatively clean. Precipitates that were present were generally located along the grain boundaries. Most dislocations observed were found to lie along one or two directions, Figure 18. Observations of dislocation-precipitate interactions were rare, due at least in part to the scarcity of precipitation.

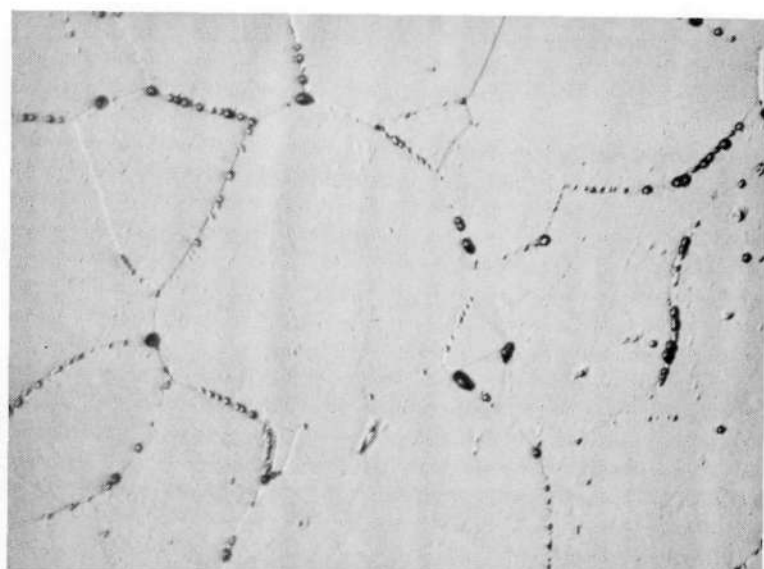
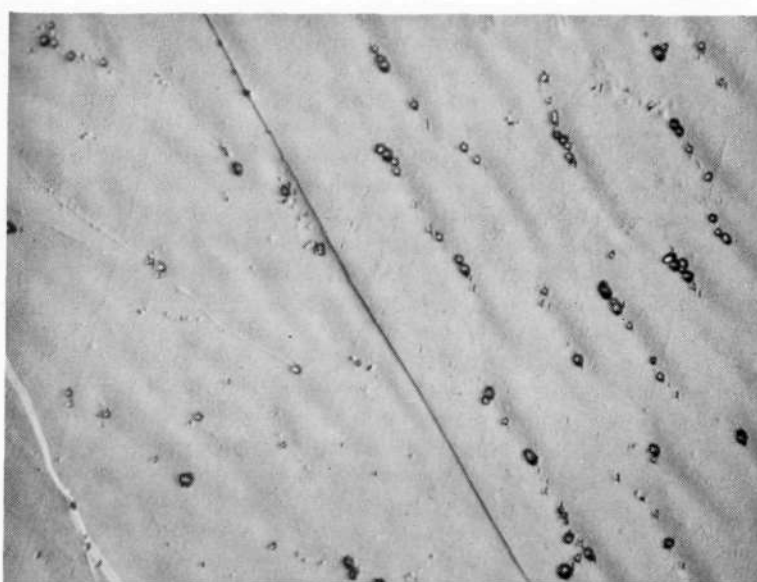
FIGURE 19. Microstructure of GTA Weld Specimen 6.

Specimen 6. Aged 10,000 hours at $1316^{\circ}\text{C}(2400^{\circ}\text{F})$, the microstructure of this specimen showed an increase in the amount of grain boundary precipitation in the heat affected zone and a decrease in the interdendritic precipitate in the fusion zone, Figure 19. Scanning micrographs of the bend-fractured specimen reveal regions of dimpled rupture together with cleavage failure, Figure 20. Certain similarities can be noted between the fracture behavior of specimen 6 and specimens 2 (Figure 9) and 5(Figure 17).

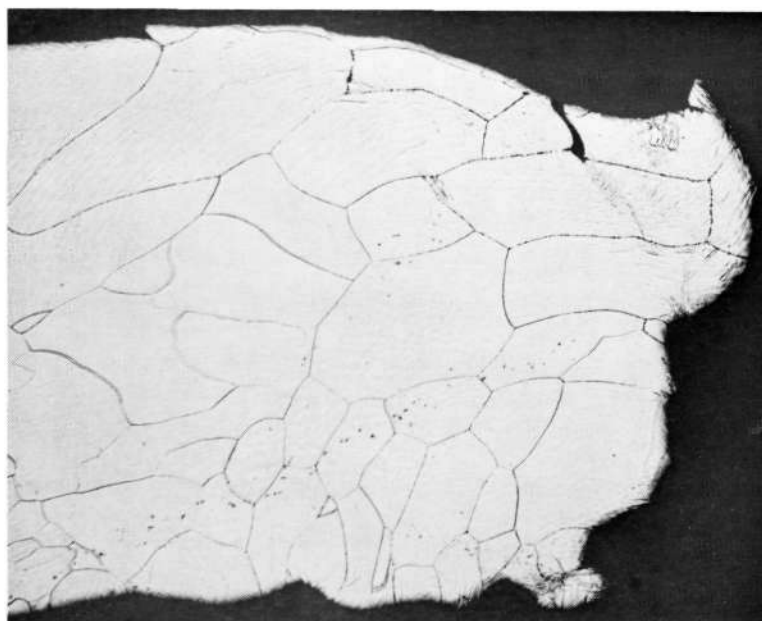
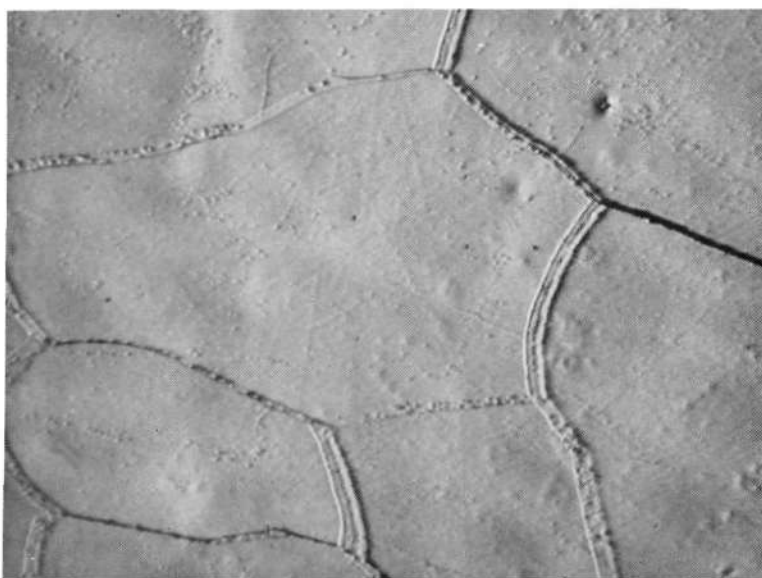
FIGURE 22. Microstructure of GTA Weld Specimen 7.

Specimen 7. This specimen was given a 1 hour- $1982^{\circ}\text{C}(3600^{\circ}\text{F})$ anneal after aging for 10,000 hours at $1316^{\circ}\text{C}(2400^{\circ}\text{F})$. Little evidence of the prior weld structure remains in the fusion zone, Figure 22, and the grain boundary regions exhibit a peculiar broadening effect. Fracture morphology is mixed with regions of dimpled rupture and cleavage, Figure 23. Precipitates are associated with most of the regions of ductile rupture. TEM on this specimen indicated a structure much like that of specimen 6, with precipitates being found only at or very near the grain boundaries.

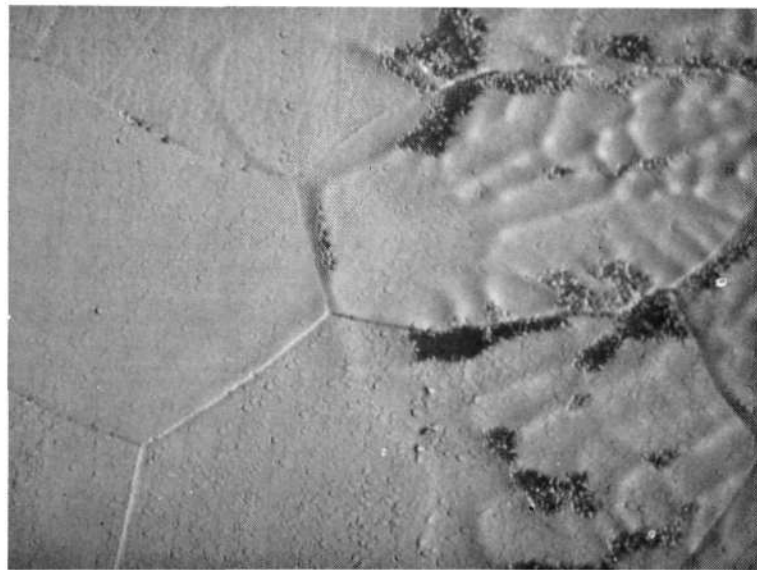
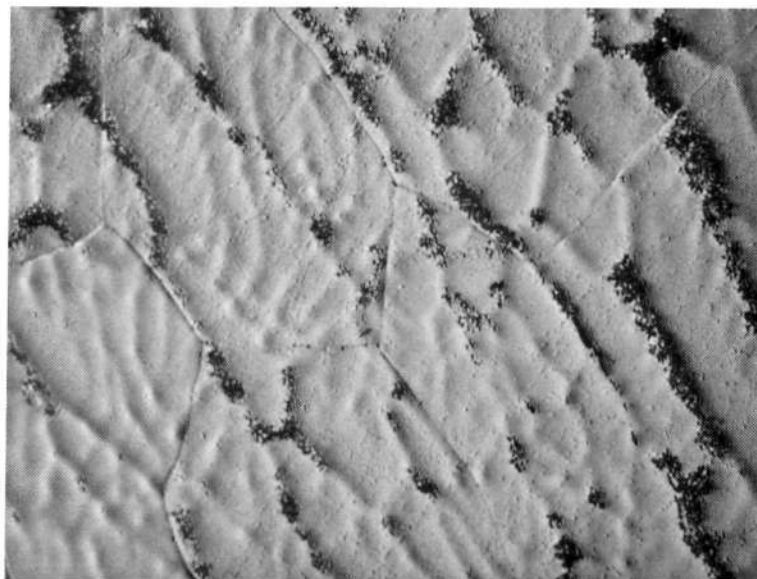
FIGURE 24. Microstructure of GTA Weld Specimen 8.

Specimen 8. This specimen was aged 1000 hours at 1149°C (2100°F). The microstructure is similar to that observed previously (specimen 3) after aging at that temperature. Precipitation is occurring interdendritically in the weld fusion zone but virtually nowhere else, Figure 24. SEM examination of the bend-fractured specimen, Figure 25, revealed regions of ductile failure, intergranular fracture and cleavage. Preference for one mode of failure over the others appeared to depend on the orientation of the grain structure with respect to the bending plane. A good foil was not obtained from the weld zone for transmission electron microscopy. A foil prepared from base metal revealed only the presence of isolated grain boundary precipitates.

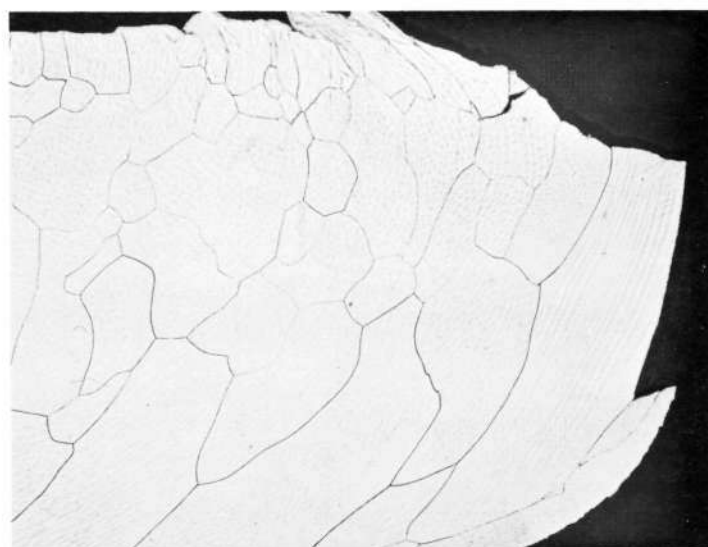
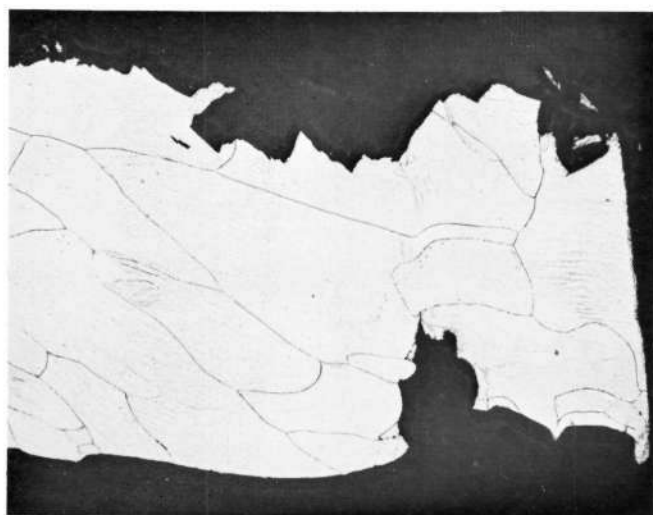
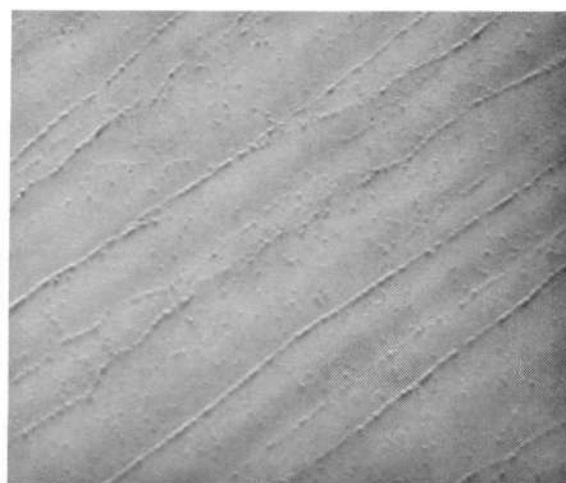
Specimen 9. This specimen was aged 1000 hours at 1149°C (2100°F) and given a 1 hour post-age anneal at 1982°C (3600°F). The high temperature anneal has reduced the evidence of interdendritic precipitation in the fusion zone, Figure 26. The section in Figure 26 showing the fracture indicates considerable deformation occurred prior to failure. Scanning micrographs of the bend-fractured specimen are similar to those of the other specimens given the 1982°C (3600°F) post-age anneal. Regions of cleavage and dimpled fracture are intermixed, Figure 27, with precipitates typically associated with the ductile regions.

FIGURE 26. Microstructure of GTA Weld Specimen 9.

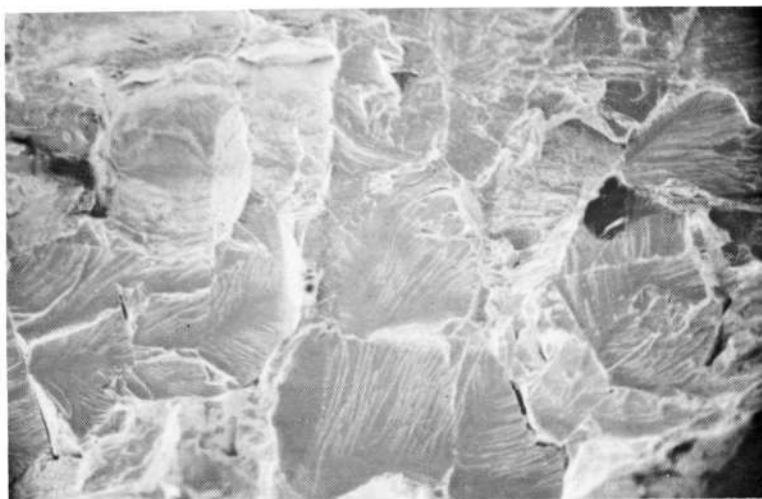
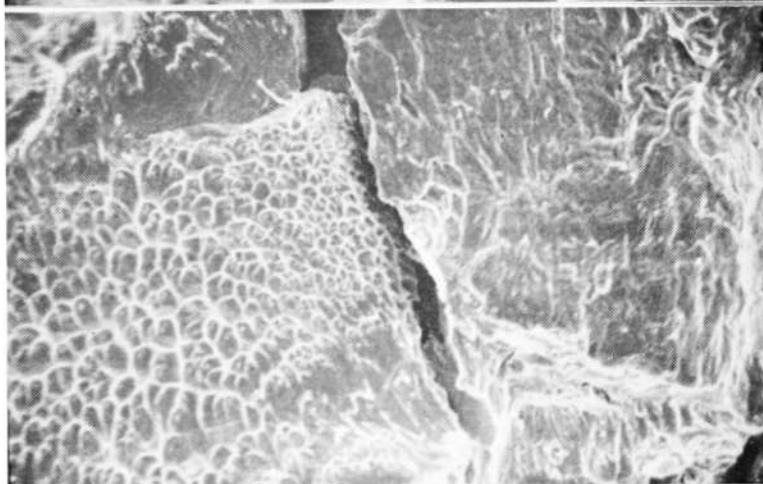
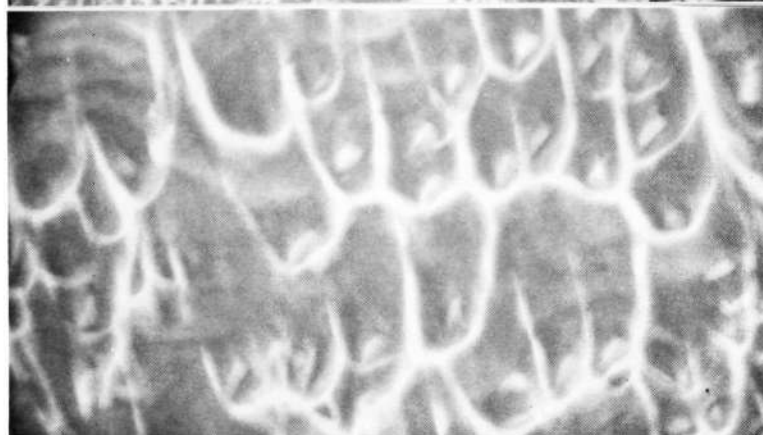
FIGURE 27. Scanning Electron Micrographs of Fracture Surface of GTA Weld Specimen 9 ; Fractured at -196°C (-320°F).

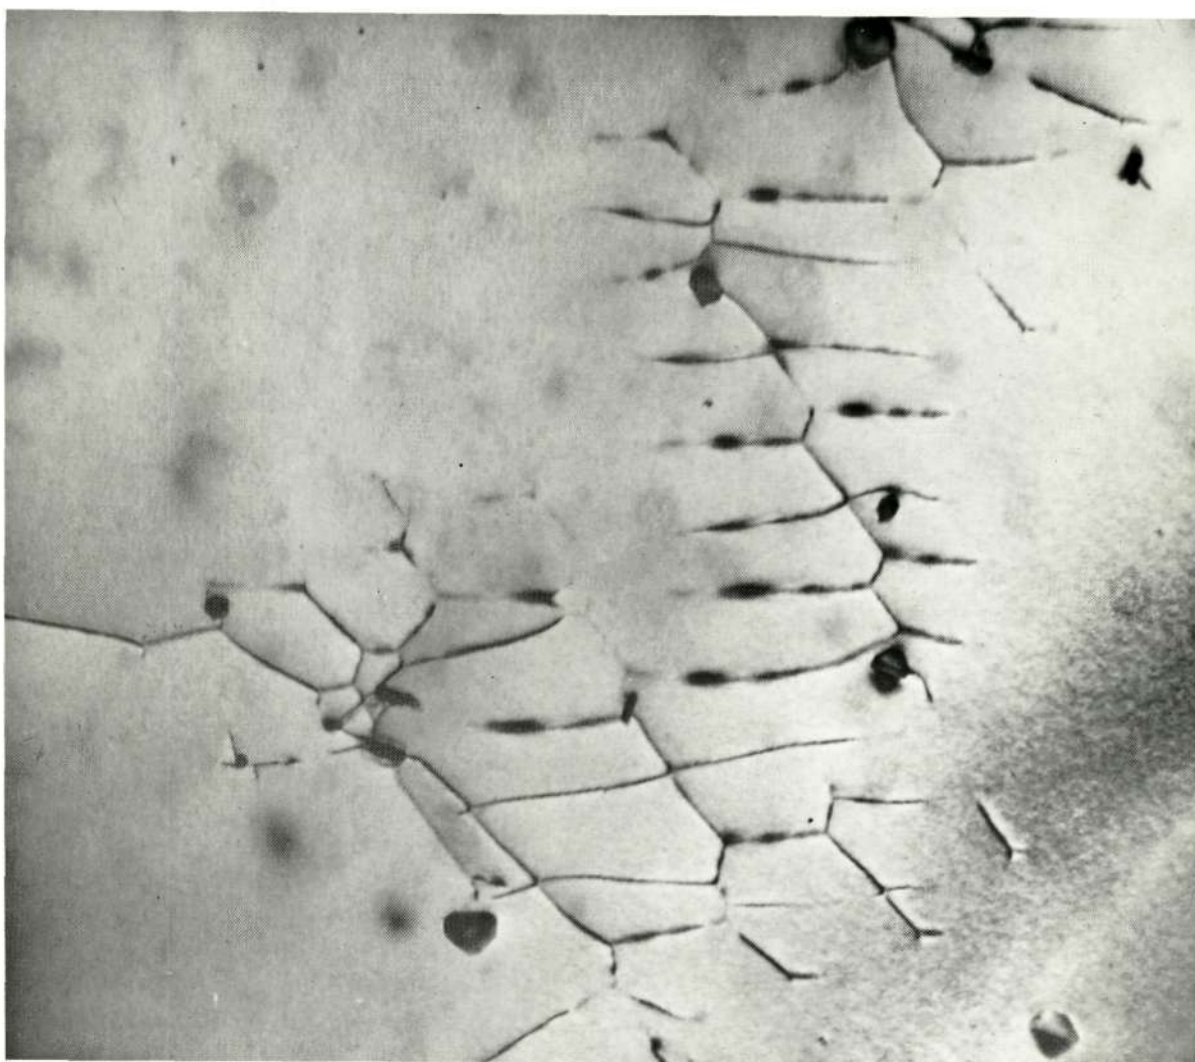
Transmission electron microscopy revealed the matrix to have an exceptionally low dislocation density, presumably due to the "cleaning-up" effect of the high temperature post-age anneal. The general matrix condition can be seen by reference to Figure 28 where we observe dislocation interactions with some of the few intragranular precipitates present. Figure 29 shows two micrographs of HfO_2 particles along a grain boundary in the weld fusion zone. Note the near total absence of dislocations in the vicinity of the boundary.

FIGURE 28. Transmission Electron Micrograph of GTA
Weld Specimen 9.

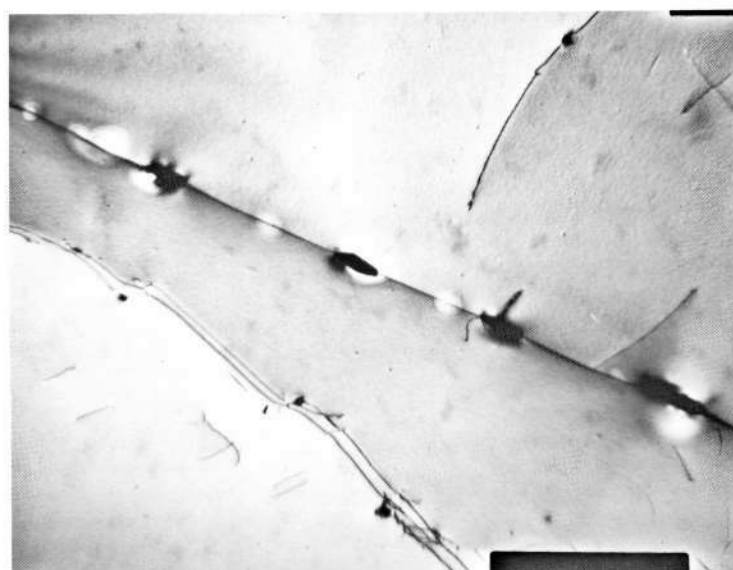
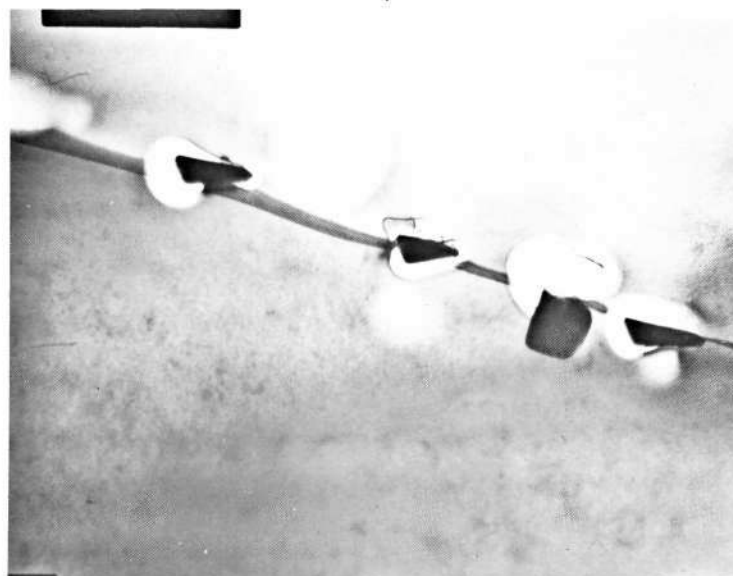
FIGURE 29. Transmission Electron Micrographs of GTA Weld Specimen 9.

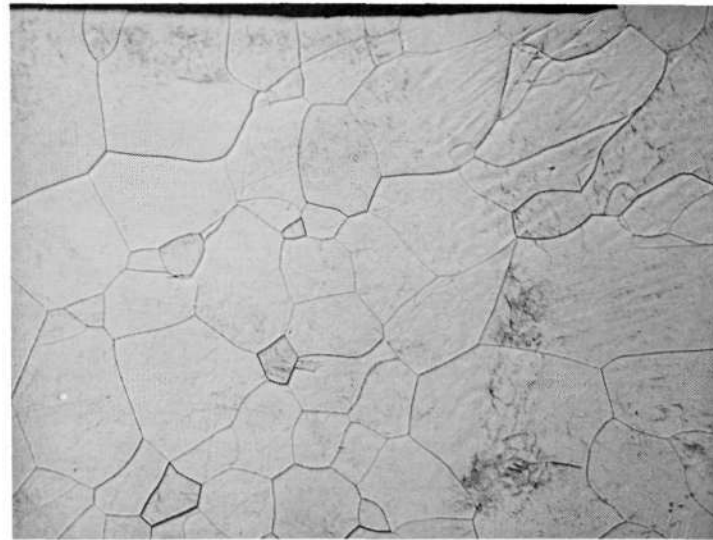
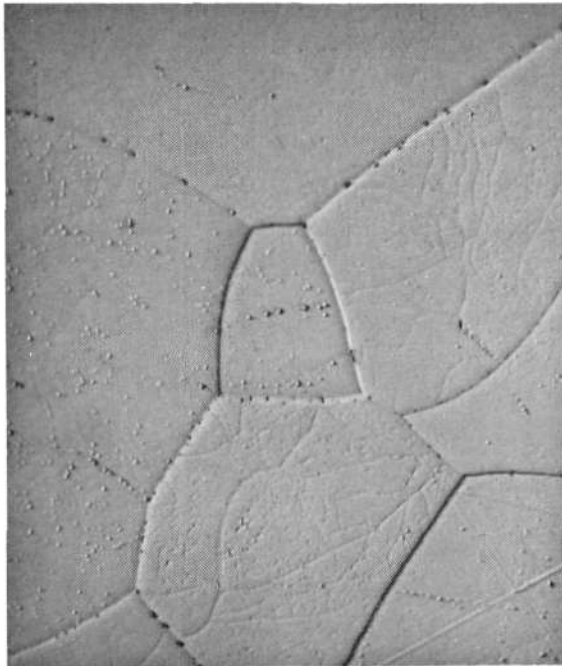
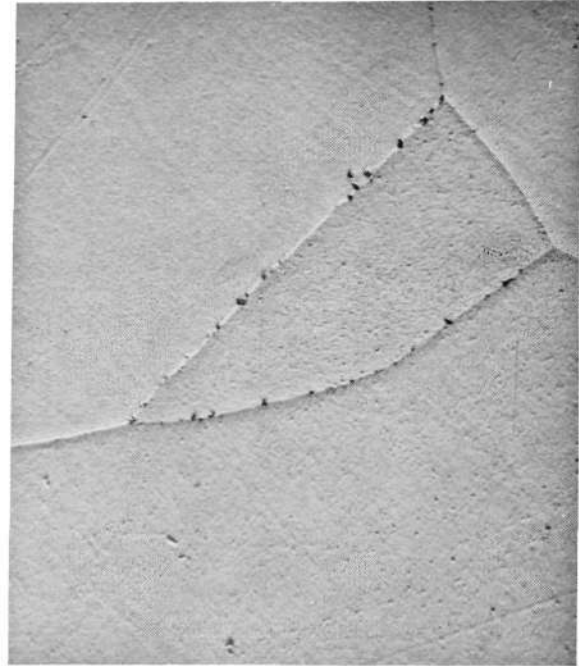
FIGURE 30. Microstructure of GTA Weld Specimen 10.

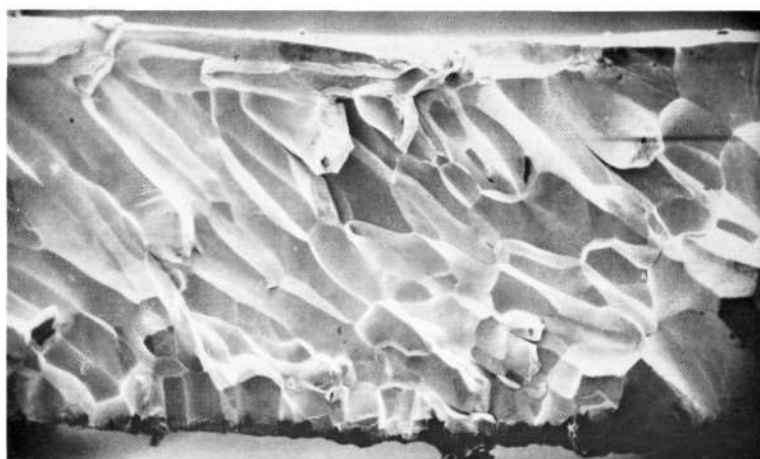
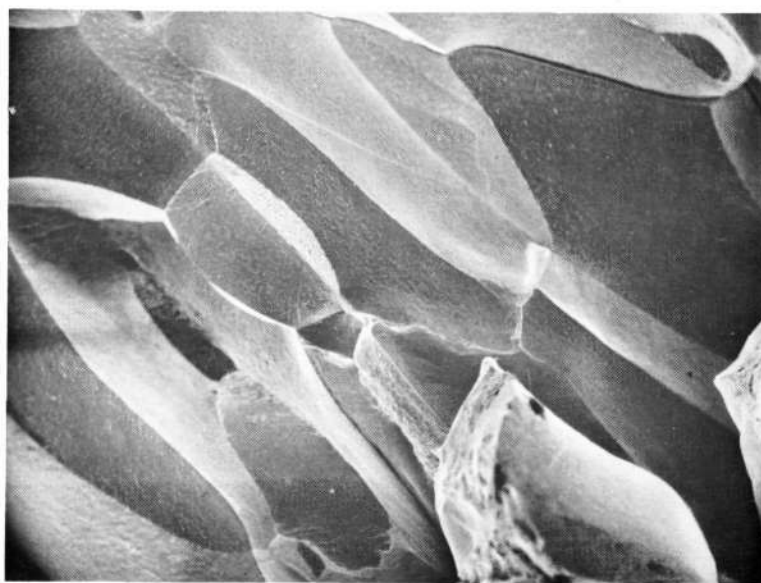
Scanning micrographs of the fracture surfaces of the bend-fractured specimen and the Auger-fractured specimen are presented in Figures 31 and 32, respectively. Both specimens display predominantly intergranular fracture although the Auger specimen, tested at a slightly higher temperature, does exhibit regions of dimpled rupture, usually associated with areas of high grain boundary precipitate density.

FIGURE 31. Scanning Electron Micrographs of Fracture Surface of GTA Weld Specimen 10 ; Fractured at -196°C (-320°F).

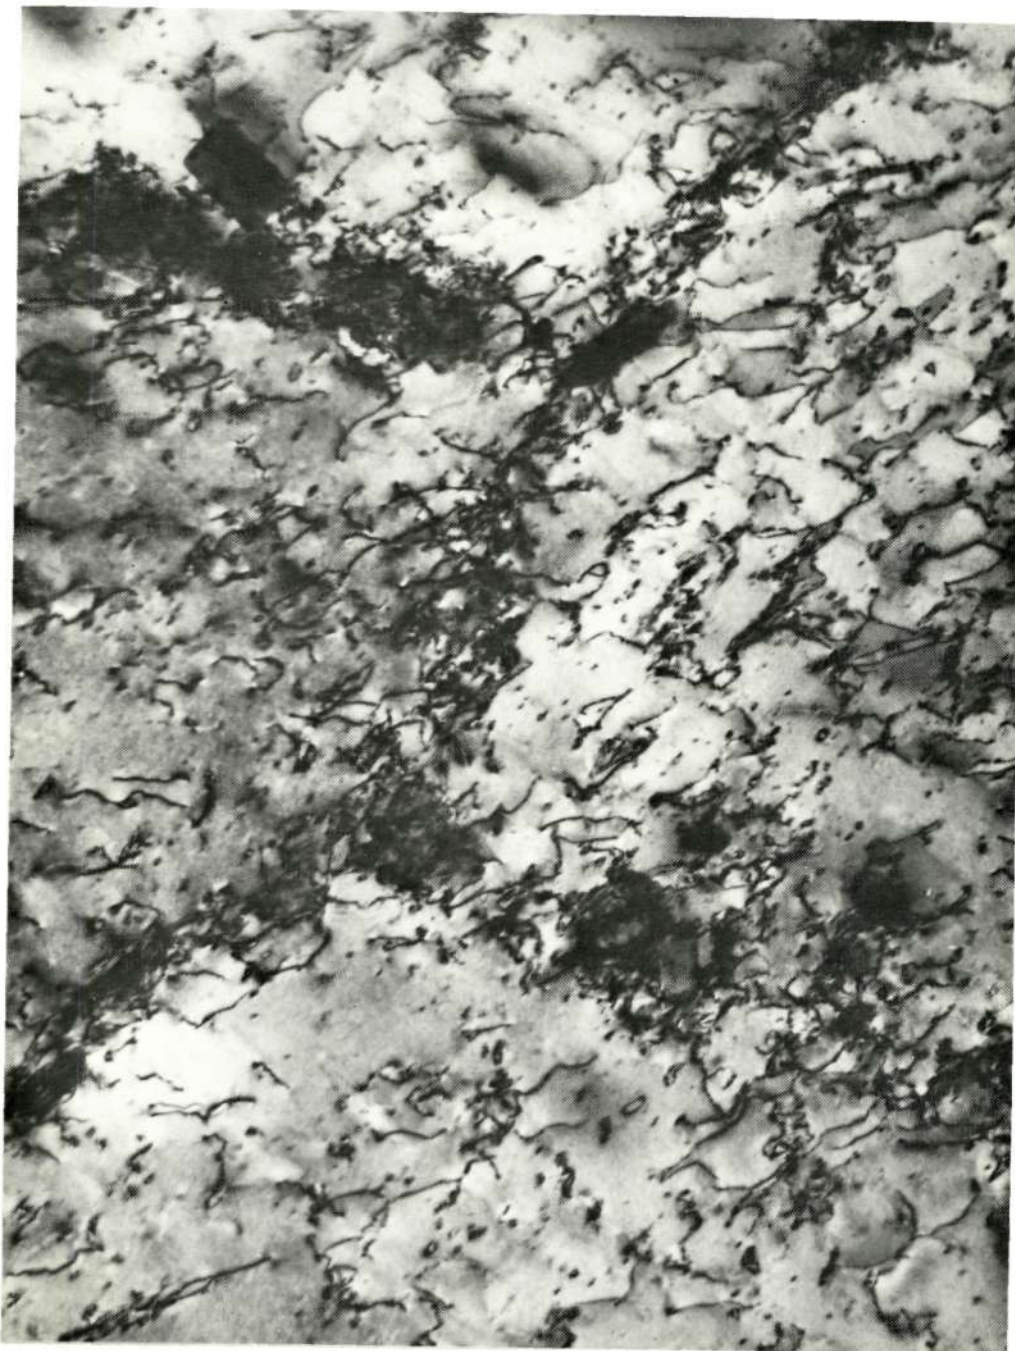
A transmission micrograph of a region within the fusion zone and very near the fracture is shown in Figure 33. The sub-boundaries present were probably formed by dislocation rearrangements occurring during the post-weld anneal while the tangles of matrix dislocations more likely occurred during bend-fracturing. At lower magnifications it appeared as if dislocation-precipitate interactions were responsible for the tangles seen; however, examination at higher magnifications established the lack of matrix precipitation.

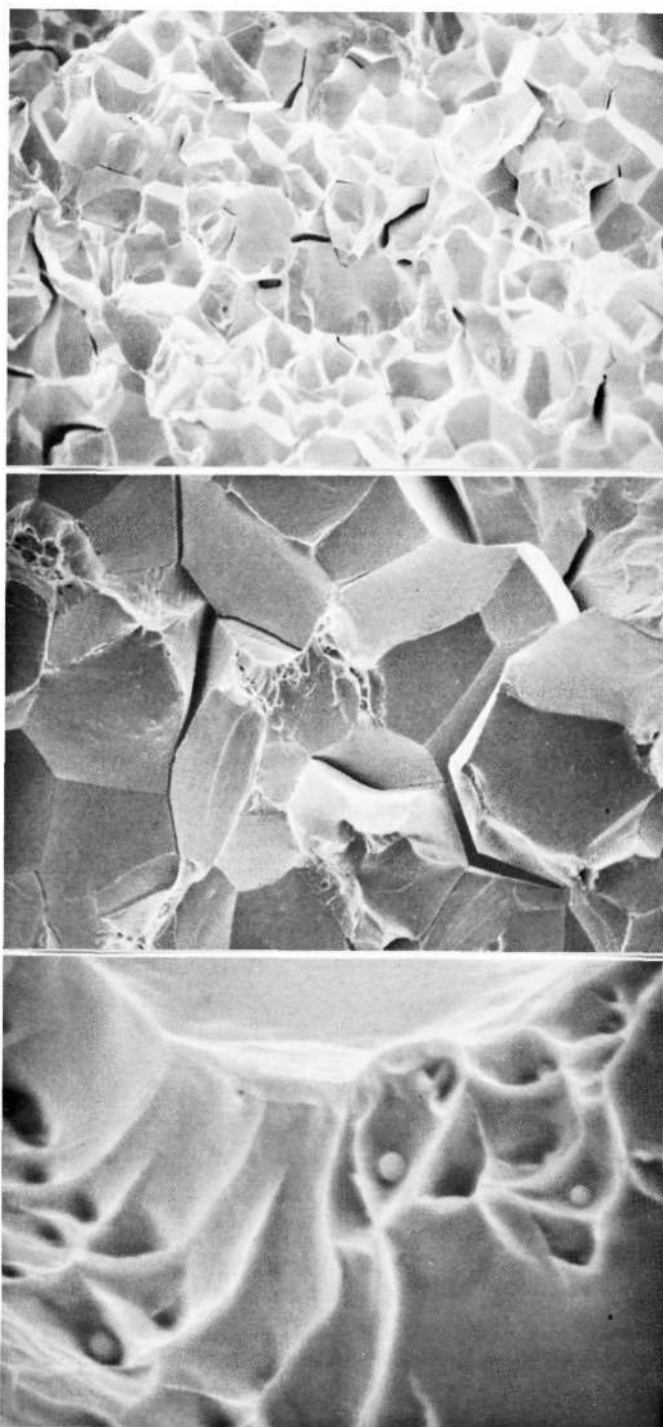
Scanning micrographs of the fracture surface of the specimen bend-fractured at -196°C (-320°F) are shown in Figure 35. The fracture is $>90\%$ intergranular with isolated regions of

FIGURE 35. Scanning Electron Micrographs of Fracture Surface of T-111 Tube Specimen 11 ; Fractured at -196°C (-320°F).

dimpled rupture. Precipitates were invariably associated with the dimpled regions. Micrographs of the Auger tested specimen, Figure 36, show a completely different picture. The fracture displays very high ductility, indicating failure occurred largely due to transgranular shear. The reason for this difference was not immediately obvious but three possible explanations were possible based on the slightly different pre-evaluation histories:

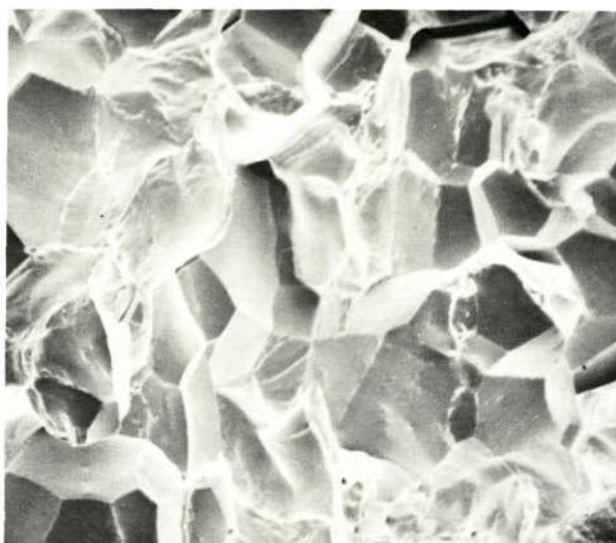
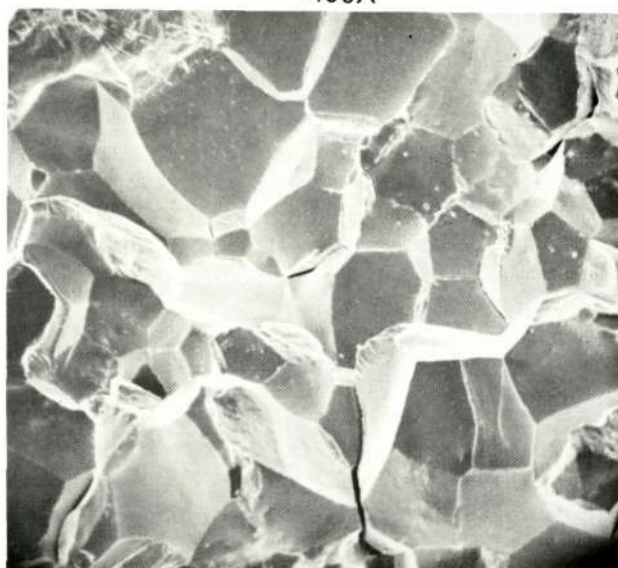
By preparing a series of full section tube wall specimens (Figure 4c) and testing in a controlled set of conditions we were able to establish the third possibility as responsible for the behavior observed. Hence, a specimen was prepared for Auger analysis without the use of a post-machine anneal. Following Auger analysis the fracture surface was examined by SEM, Figure 37. The fracture was 80-90% intergranular, in agreement with the specimen bend-fractured at $-196^{\circ}\text{C}(-320^{\circ}\text{F})$, Figure 35.

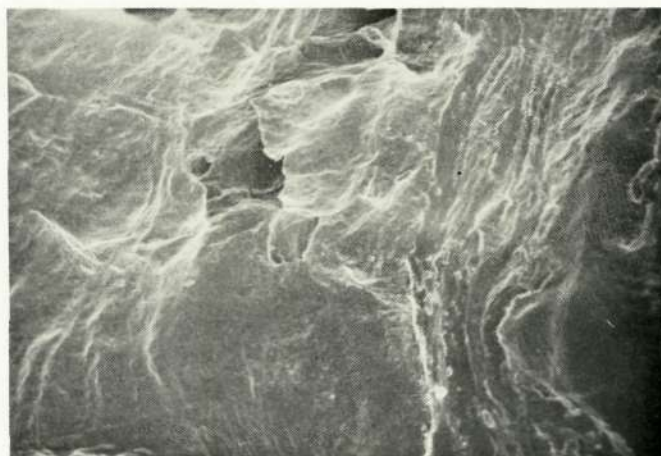
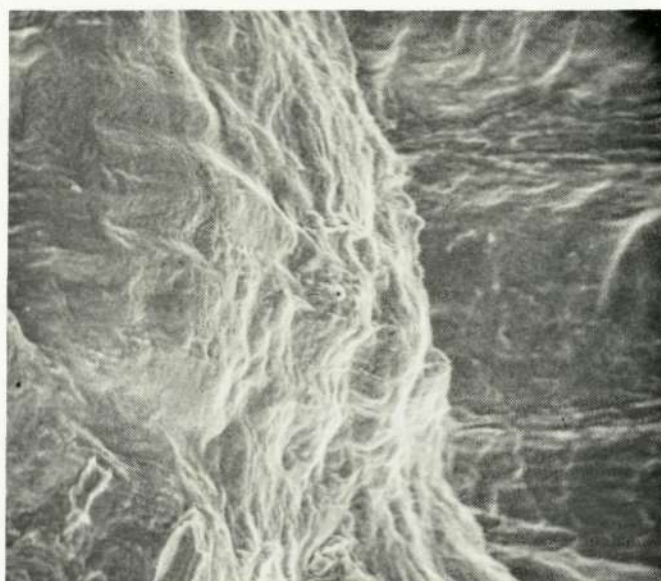
Scanning micrographs of the specimen bend-fractured at -196°C (-320°F) are presented in Figure 40. Fracture has occurred by a mixed mode, with regions of intergranular, cleavage and ductile rupture all present. As we found for specimen 11, the initial Auger specimen, which had been annealed 1 hour at 982°C (1800°F) prior to testing, failed by transgranular shear at very high ductility, Figure 41. Although not as dramatically different as for specimen 11, again a change in behavior was indicated.

FIGURE 40. Scanning Electron Micrographs of Fracture Surface of T-111 Tube Specimen 12 ; Fractured at -196°C (-320°F).

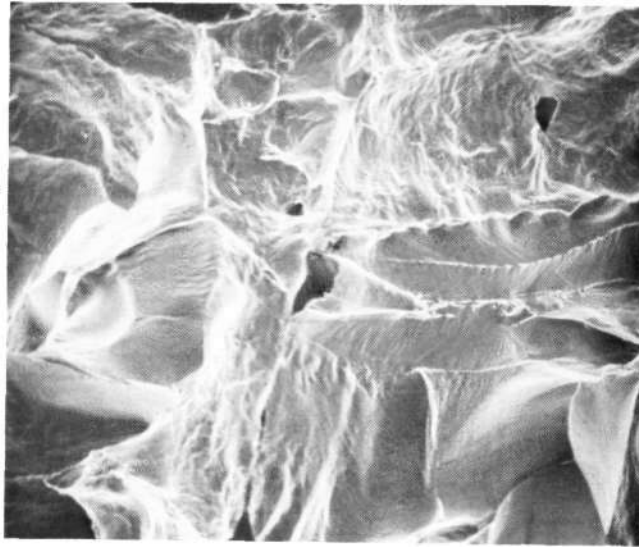
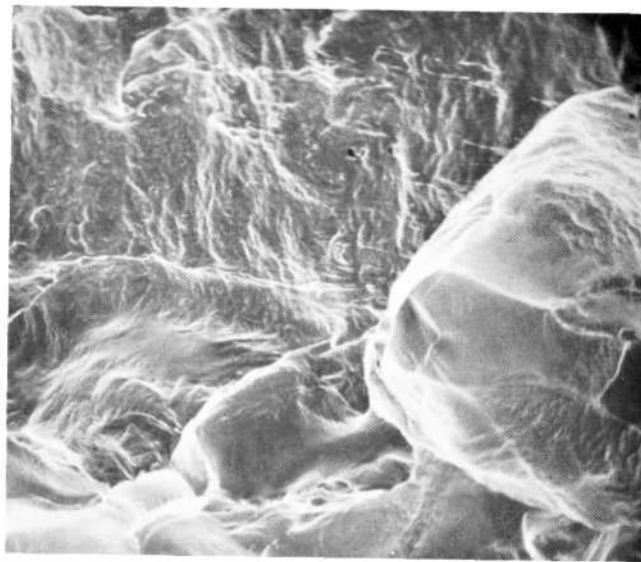
FIGURE 41. Scanning Electron Micrographs of Fracture Surface of T-111
Tube Specimen 12 ; Fractured in Auger Apparatus at -150°C
(-238°F). Annealed 1 Hour-982°C (1800°F) Prior to Testing.
